**DEPARTMENT OF TRANSPORTATION**

Contract #: 04-0120F4Cty: SF/ALA Rte: 80 PM: 13.2/13.9File #: 69.28**WELDING INSPECTION REPORT****Resident Engineer:** Siegenthaler, Peter**Address:** 333 Burma Road**City:** Oakland, CA 94607**Report No:** WIR-018234**Date Inspected:** 17-Nov-2010**Project Name:** SAS Superstructure**OSM Arrival Time:** 700**Prime Contractor:** American Bridge/Fluor Enterprises, a JV**OSM Departure Time:** 1900**Contractor:** Zhenhua Port Machinery Company, Ltd (ZPMC), Changxing Island **Location:** Shanghai, China**CWI Name:** Xu Tao**CWI Present:** Yes No**Inspected CWI report:** Yes No N/A**Rod Oven in Use:** Yes No N/A**Electrode to specification:** Yes No N/A**Weld Procedures Followed:** Yes No N/A**Qualified Welders:** Yes No N/A**Verified Joint Fit-up:** Yes No N/A**Approved Drawings:** Yes No N/A**Approved WPS:** Yes No N/A**Delayed / Cancelled:** Yes No N/A**Bridge No:** 34-0006**Component:** OBG Components**Summary of Items Observed:**

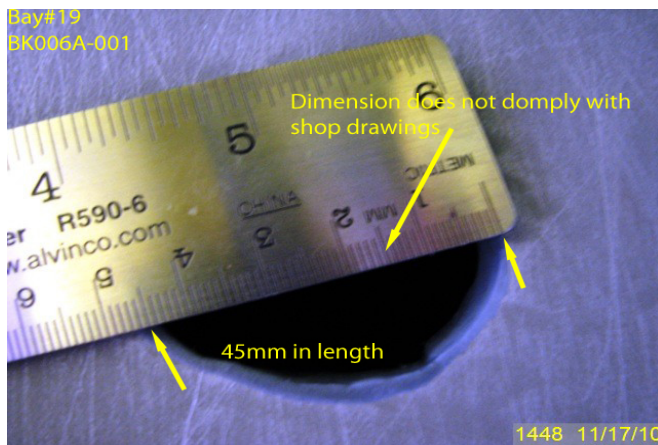
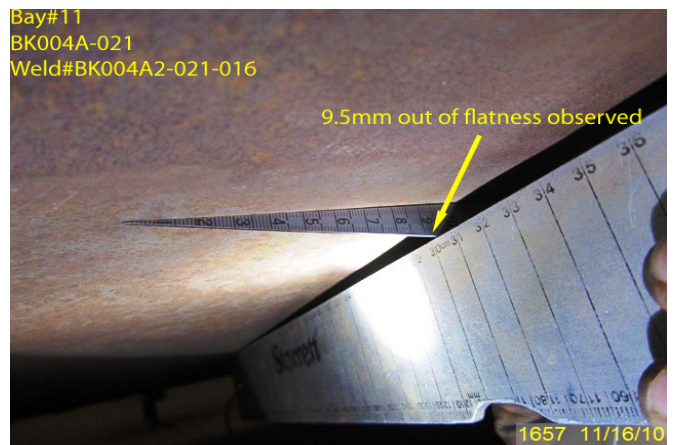
-During random DCP check, this QA inspector observed out of flatness across the weld exceed the allowable tolerance.

-The component is Bike Path bottom cover plate, seam weld.

-The thickness of the bottom plate is 6mm.

-According to the Standard Specification 1999, Section 55, flatness of the splice weld is measured by 600mm straight edge and the allowable tolerance is 5mm.

-Maximum out of flatness was observed as 9.5mm on bike path BK004A-021, weld#BK004A2-021-016,

And 7.5mm on bike path BK004A-018, weld#BK004A2-018-018.

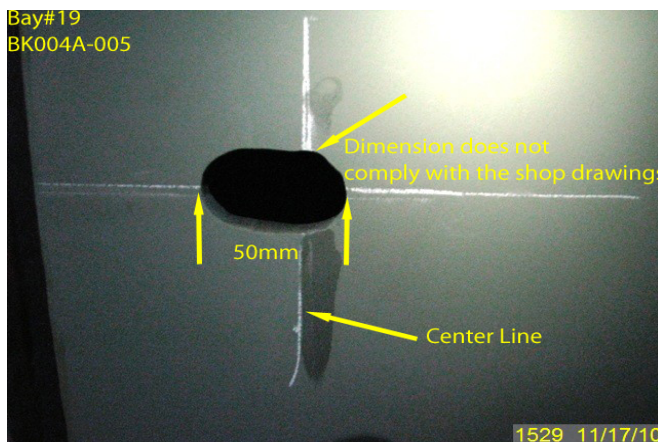
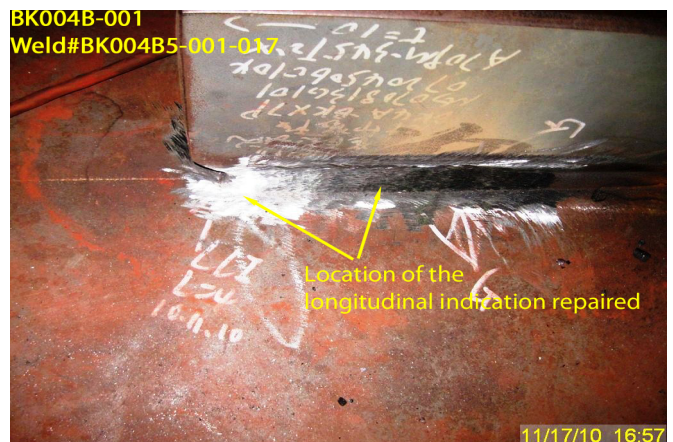
-The slotted hole on the Bike Path Bearing Plate does not comply with the approved shop drawing.

-According to the shop drawing, the dimension of the slotted hole is 64x34.

-The slotted holes were measured as 45x34.

-The bearing Plate is identified as BKPL7A (BK004A) and BKPL14A (BK006A)

-The bike path component is identified as; BK006A-001, BK004A-012 and BK004A-005.

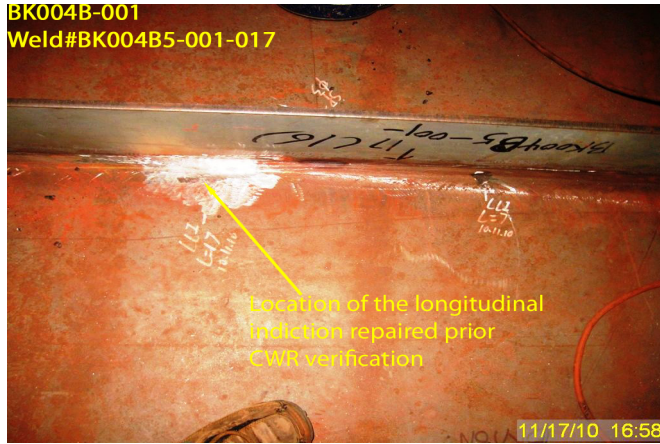
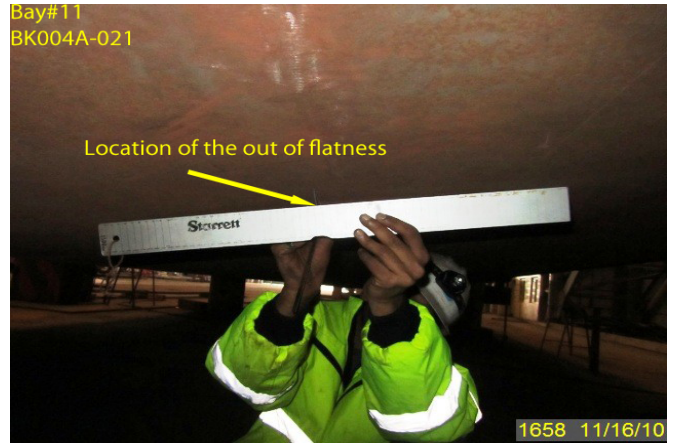
During Quality Assurance (QA) Critical Weld Repair (CWR) verification inspection at Bay#19 of Bike Path welds, this Caltrans QA Inspector observed the following issues:

- QA Inspector was notified via email for verification of B-CWR2228 R0 at 16:25 hours.
- The Bike Path component for verification was identified as BK004B-001.
- The welds are identified as; BK004B3-001-051, total three (3) linear transverse indications  
And BK004B5-001-017, total four (4) linear longitudinal indications.
- The transverse indications measuring approximately 10mm & 15mm in length and the longitudinal indications measuring approximately 15mm & 25mm were found at this location, which required an approved CWR prior to starting repairs.
- ZPMC repaired these indications prior to the QA inspector's CWR verification.
- BK004B-001 is located in Bay 19.
